Rust Belt Real Estate:

Leveraging Rehabilitation Tax Credits

Preservation Studios LLC, Buffalo, NY

March 24, 2015

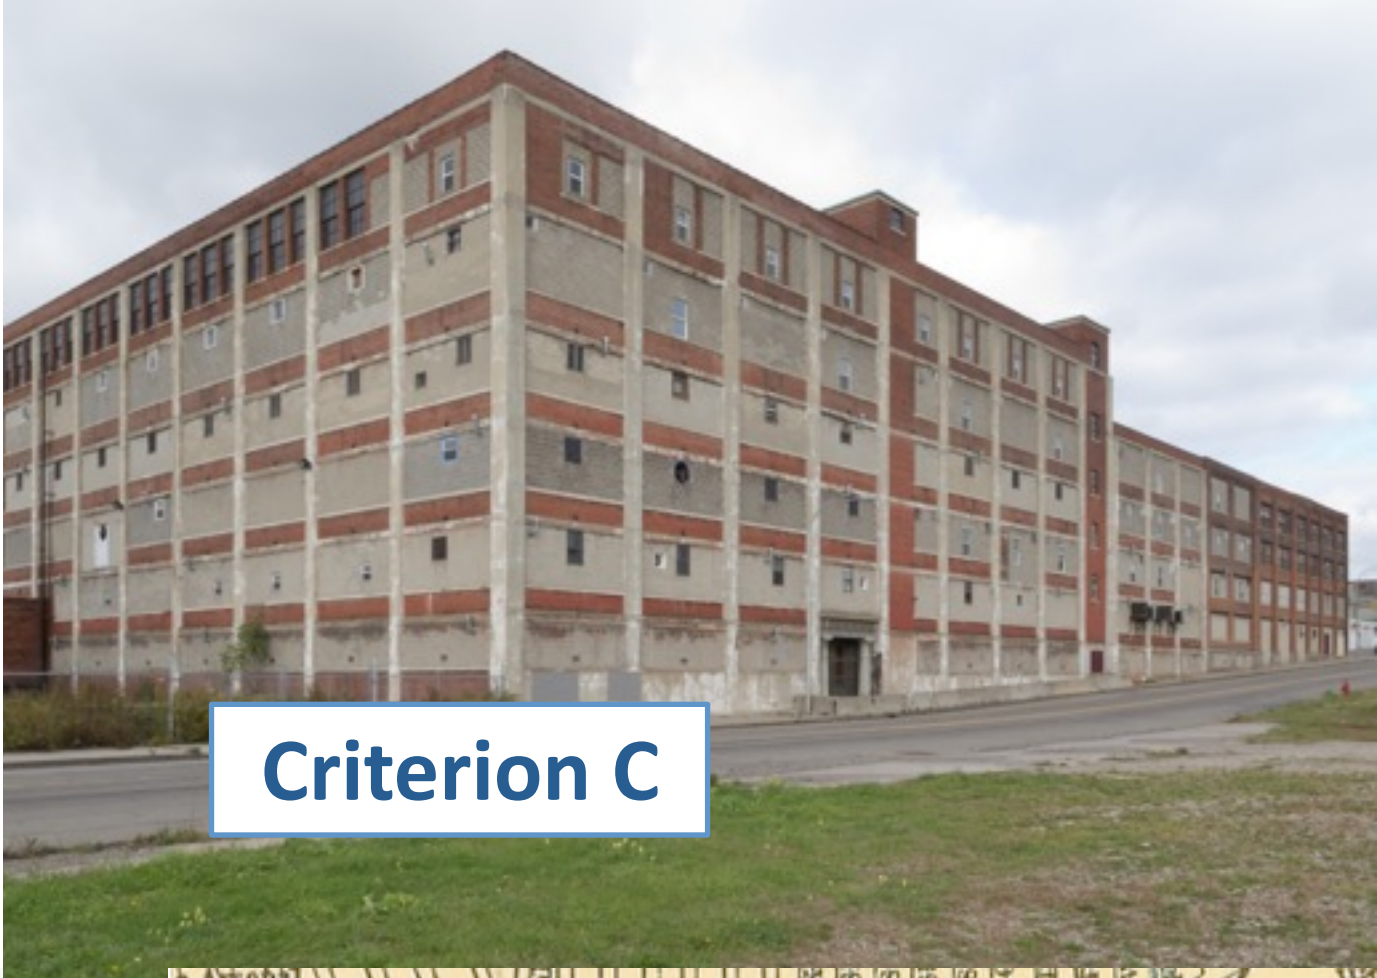
F.N. Burt Box Factory

500 Seneca St.
Buffalo, NY

- Built in parts from 1901-1927
- F.N. Burt vacated in 1959
- Bought by New ERA Cap in 1986
- Vacant since 2004

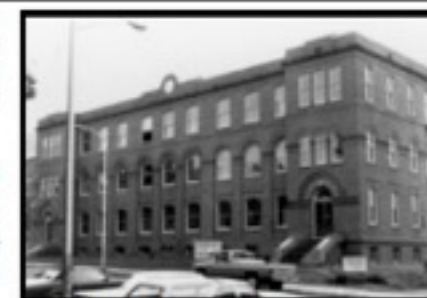
Application (Compatible treatment): A school was rehabilitated into 24 market-rate residential apartments. Begun in 1893, and dedicated in 1898, the two-story brick building was enlarged in 1926 by the addition of three bays and a third story. Details used on the 1926 addition were identical to those of the original structure. Both the interior and exterior of the recently vacated school were in nearly pristine condition prior to rehabilitation.

The school after rehabilitation. Windows, doors, and transoms were repaired. The building was not cleaned.

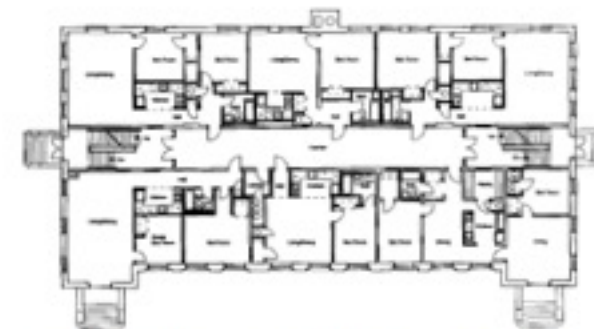
The simple plan of the school followed directly from the rectangular footprint of the buildings: classrooms and cloakrooms on each side of a central corridor with stairwells at either end. The two identical staircases, each rising from the basement to the third story, were separated from the corridor by sets of glazed fire doors with multi-paned transoms and sidelights. Panelled and glass doors with transoms lined the halls, which also retained their wainscoting, baseboard, coat hooks, metal or plaster ceilings, and wood cove molding. The large classrooms retained similar features, and some even contained original lighting fixtures and built-in cabinets. All molded window and door casings remained.

The plan after rehabilitation showing the successful insertion of approximately one unit per classroom.

A comparison of before and after photographs documents the sympathetic rehabilitation work. In the hallways, transoms were retained but infilled with fire-rated drywall on the classroom side, the coat hooks were removed, a sprinkler and fire safety system was installed, some doors were fixed in place, and carpeting was installed. Otherwise, the hallways were kept intact. Six apartments were created on each floor - three on each side of the corridors. With few exceptions, the plan was retained by inserting only one unit per classroom.

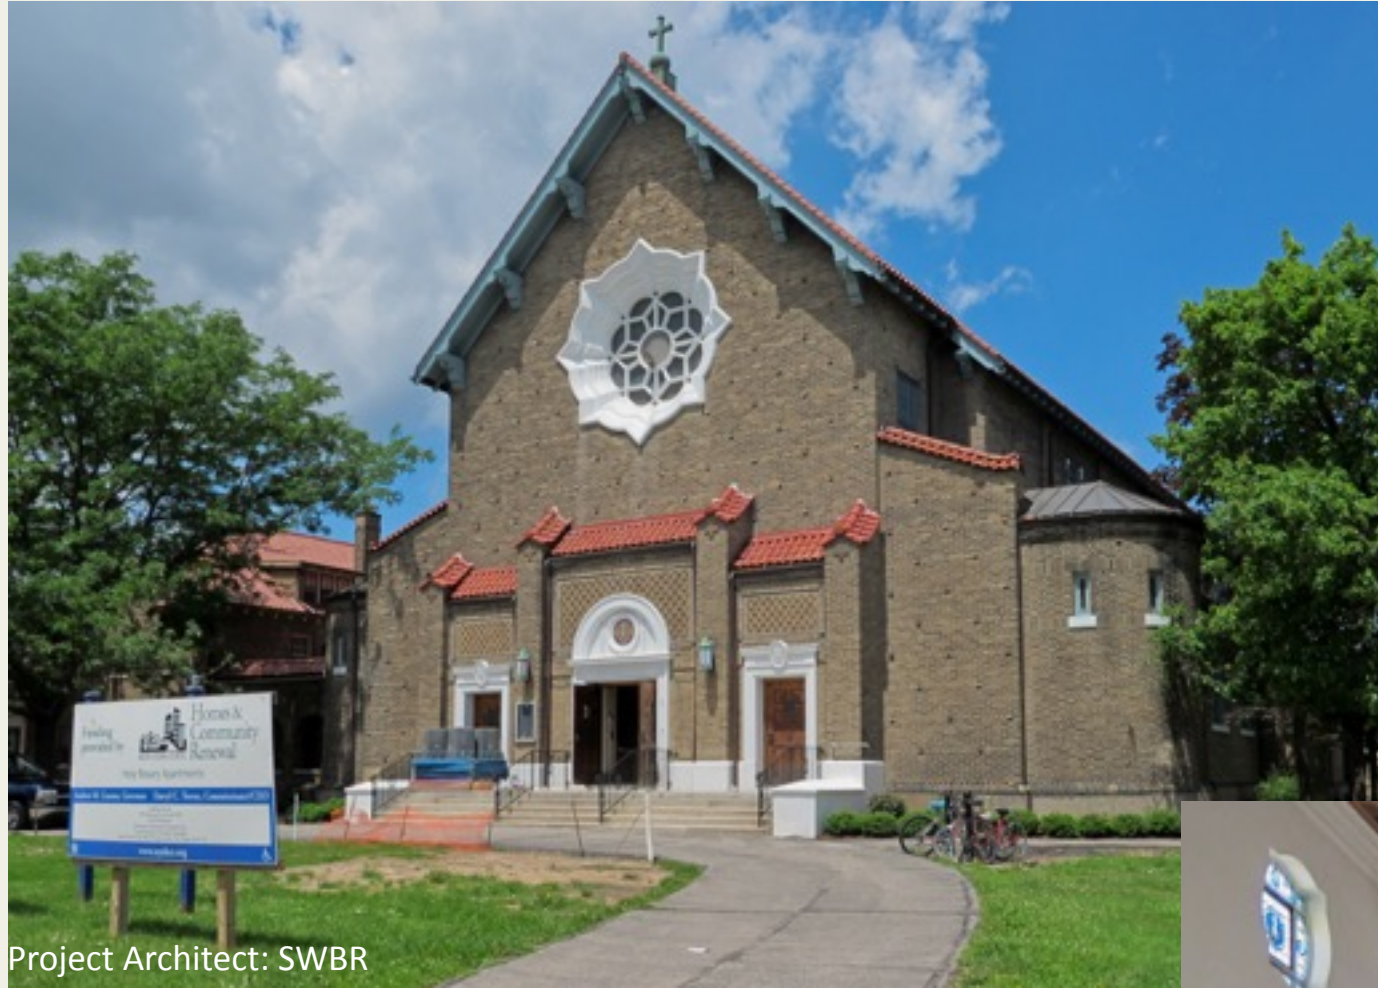
Applying the Standards: Church Complex

The historic character of a property shall be retained and preserved. The removal of historic materials or alteration of features and spaces that characterize a property shall be avoided

- NPS currently does not allow the main volume of the church to be divided significantly
- Although this present problems when attempting housing in a church, there are some creative solutions

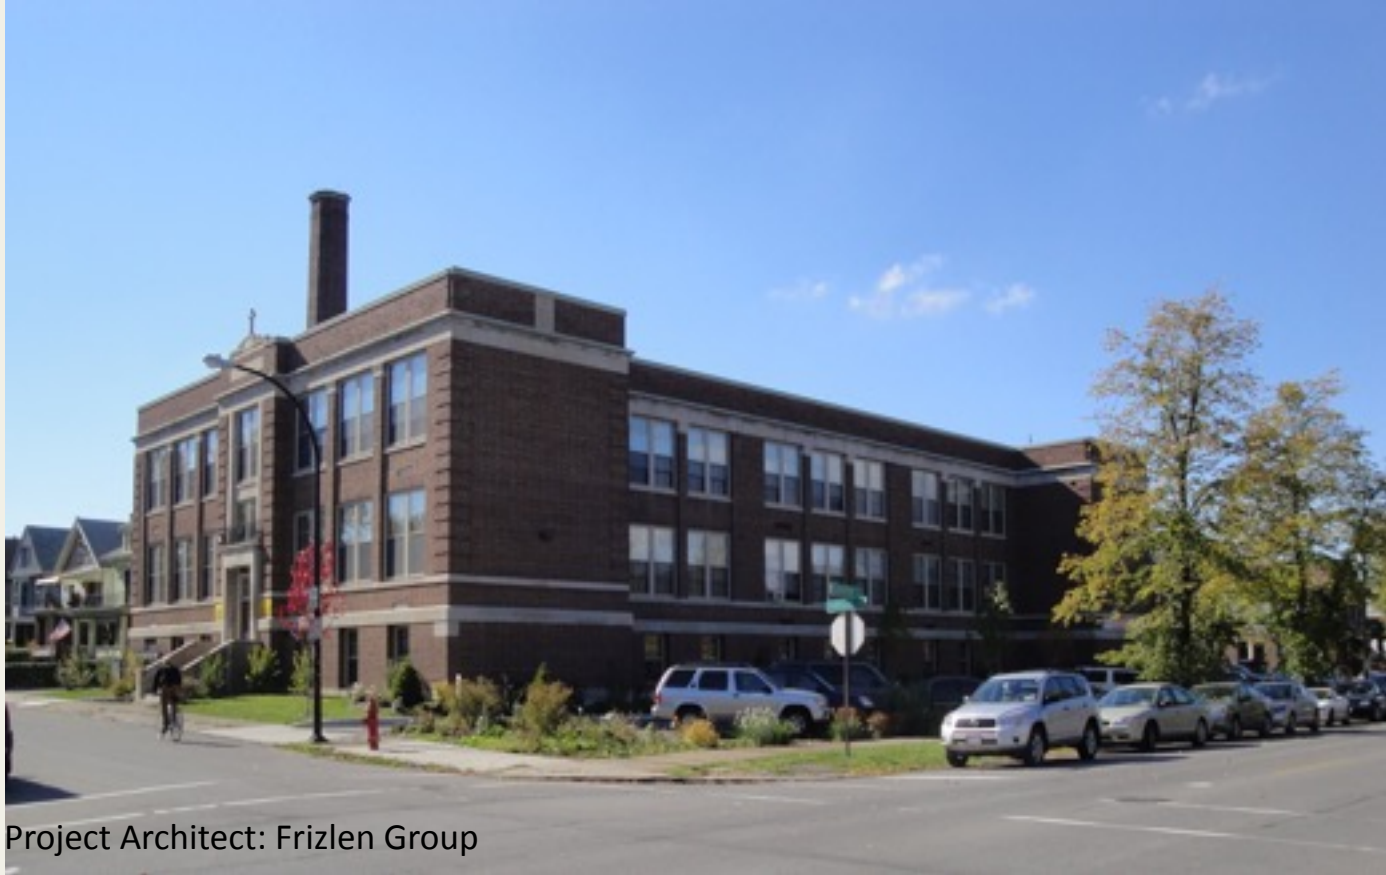
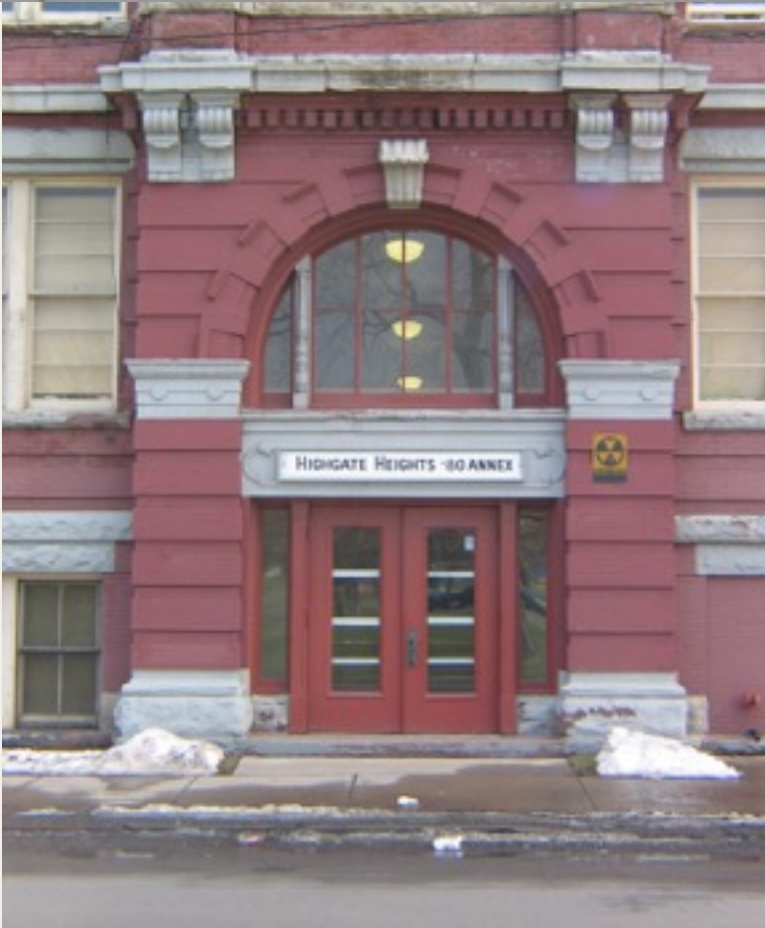
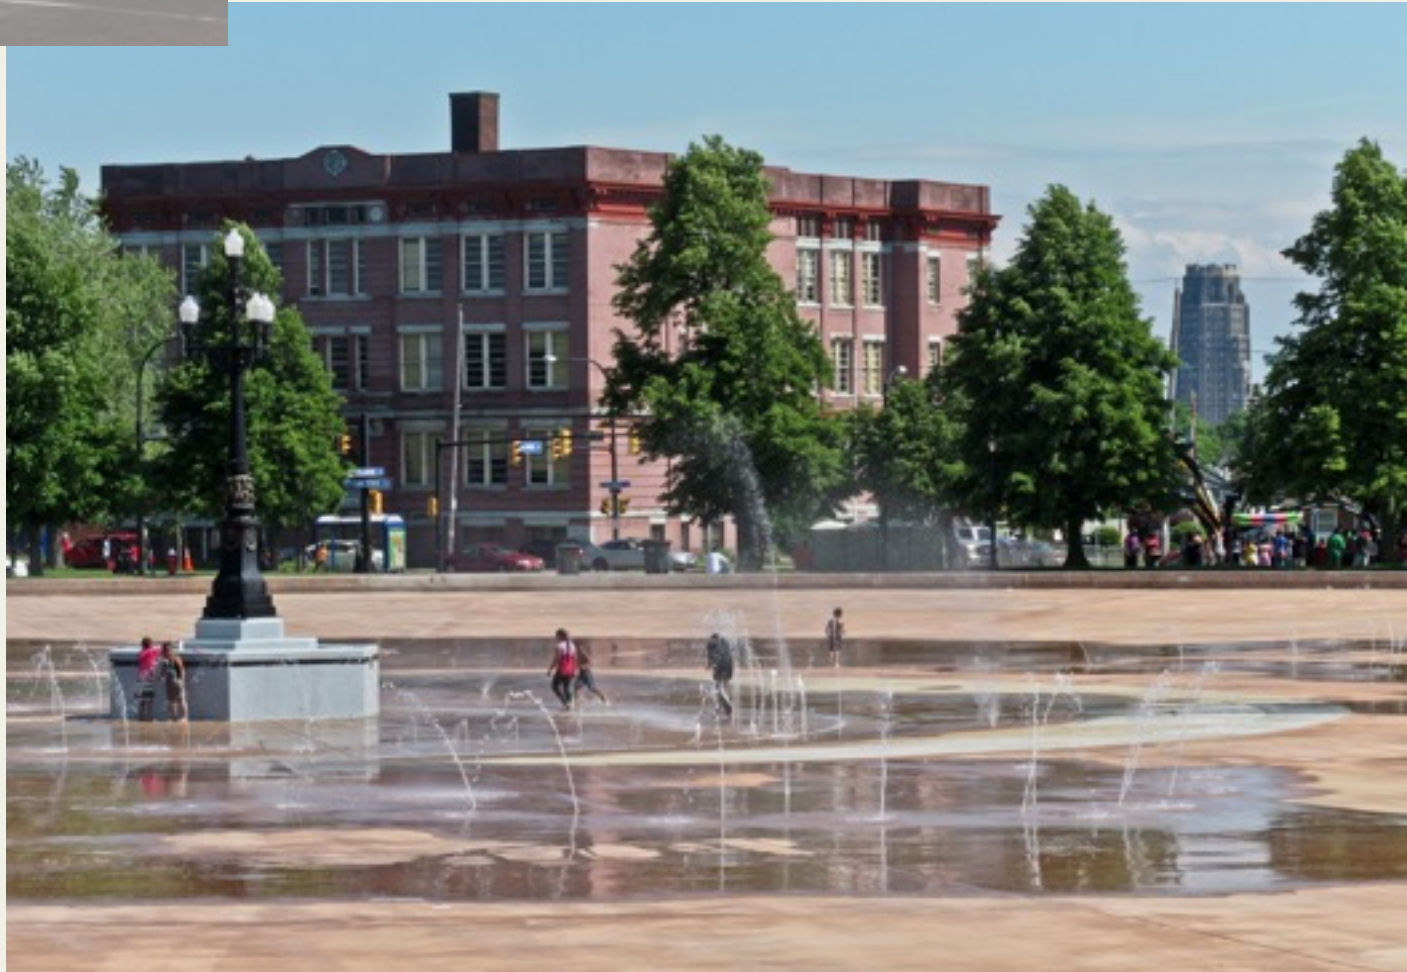
Applying the Standards: School Buildings

Standard No. 3

Each property shall be recognized as a physical record of its time, place, and use. Changes that create a false sense of historical development, such as adding conjectural features or architectural elements from other buildings, shall not be undertaken.

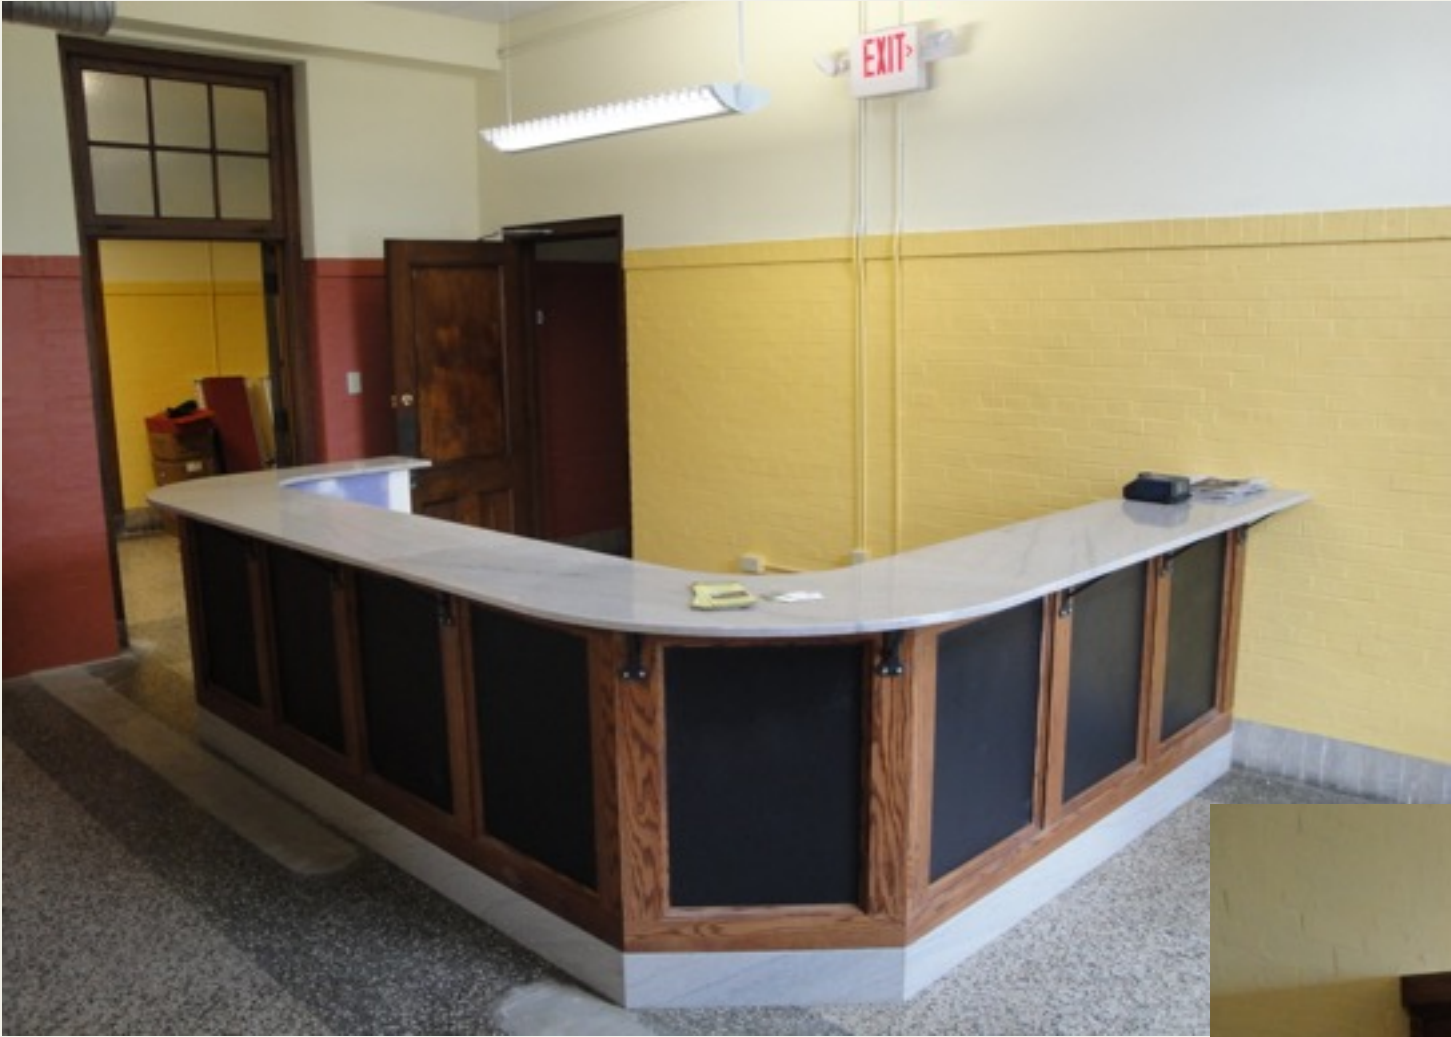
Applying the Standards: School Buildings

Reusing materials that would otherwise be discarded goes a long way with the overall project approval

It works on a case-by-case basis, but when original features can be relocated and reused in other spaces Without creating a false sense of history it's a plus

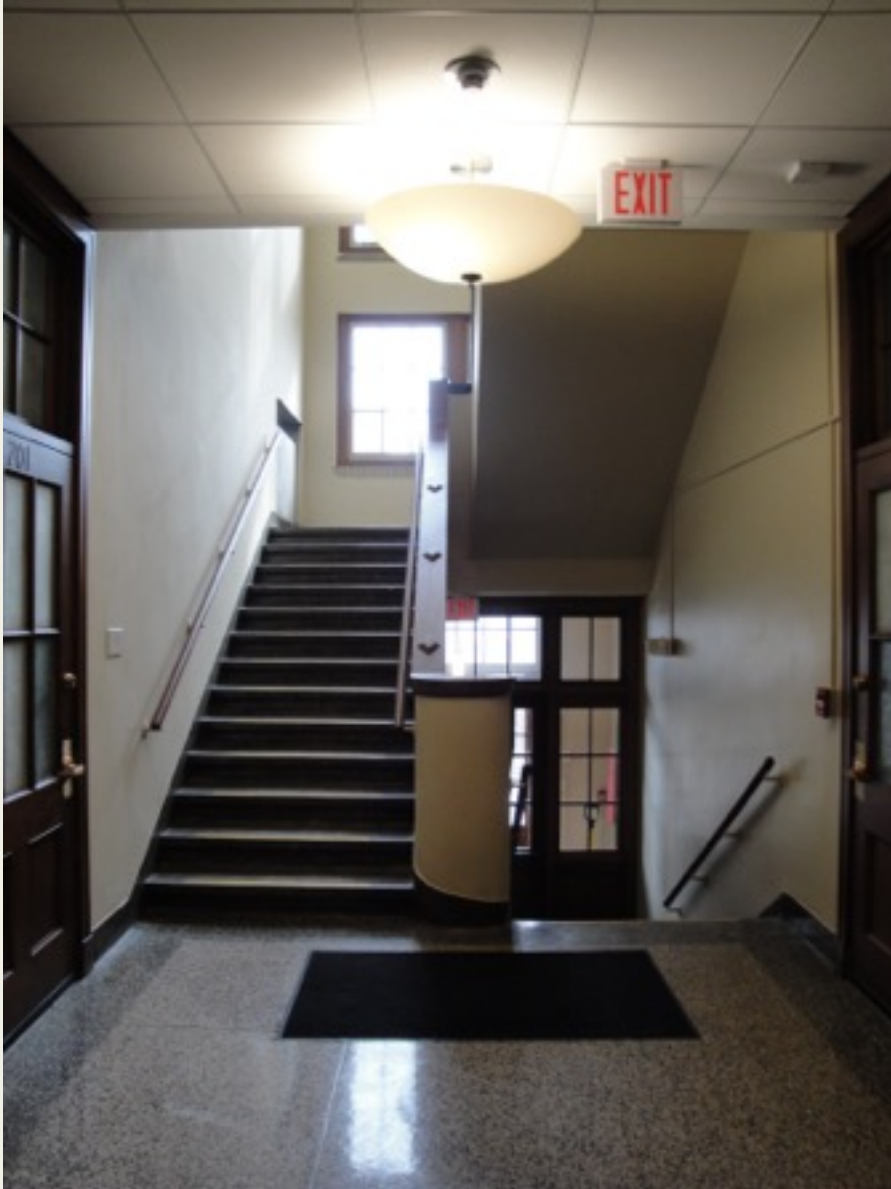
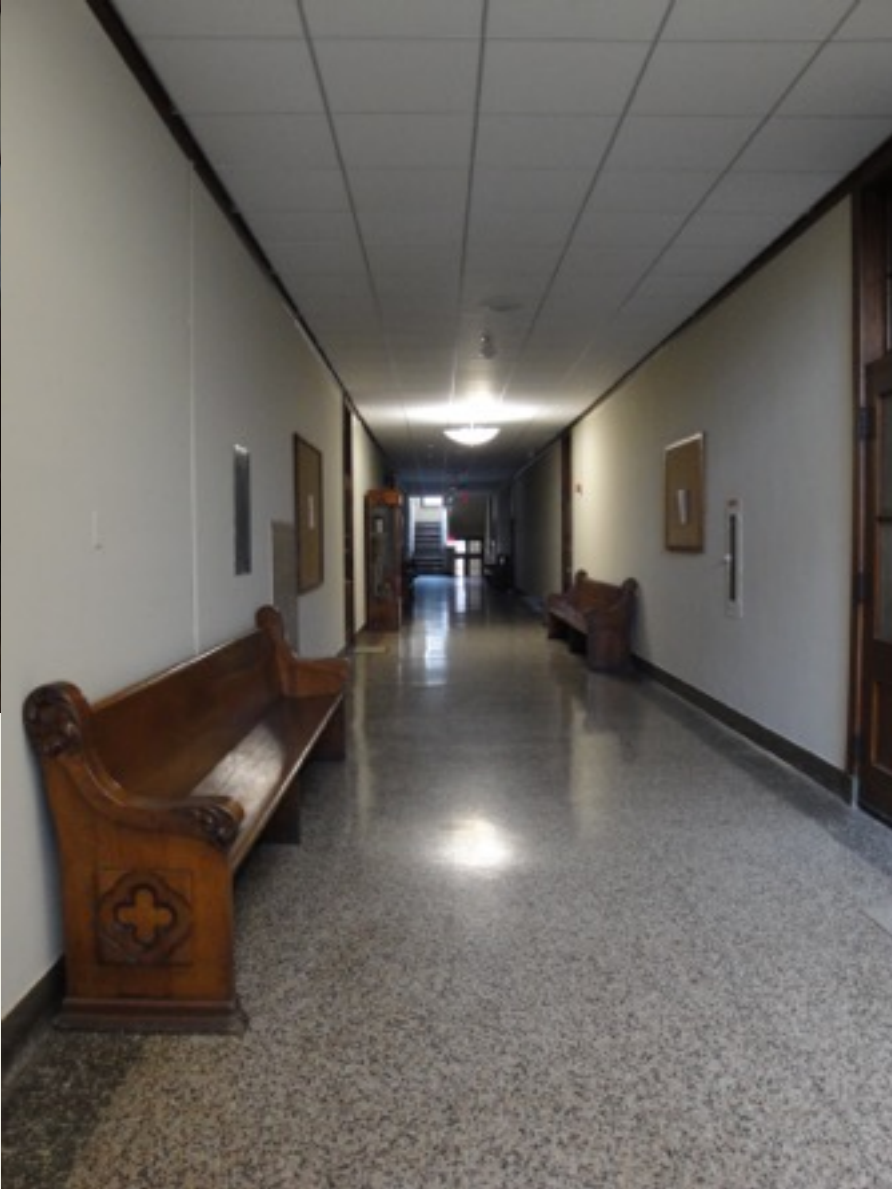
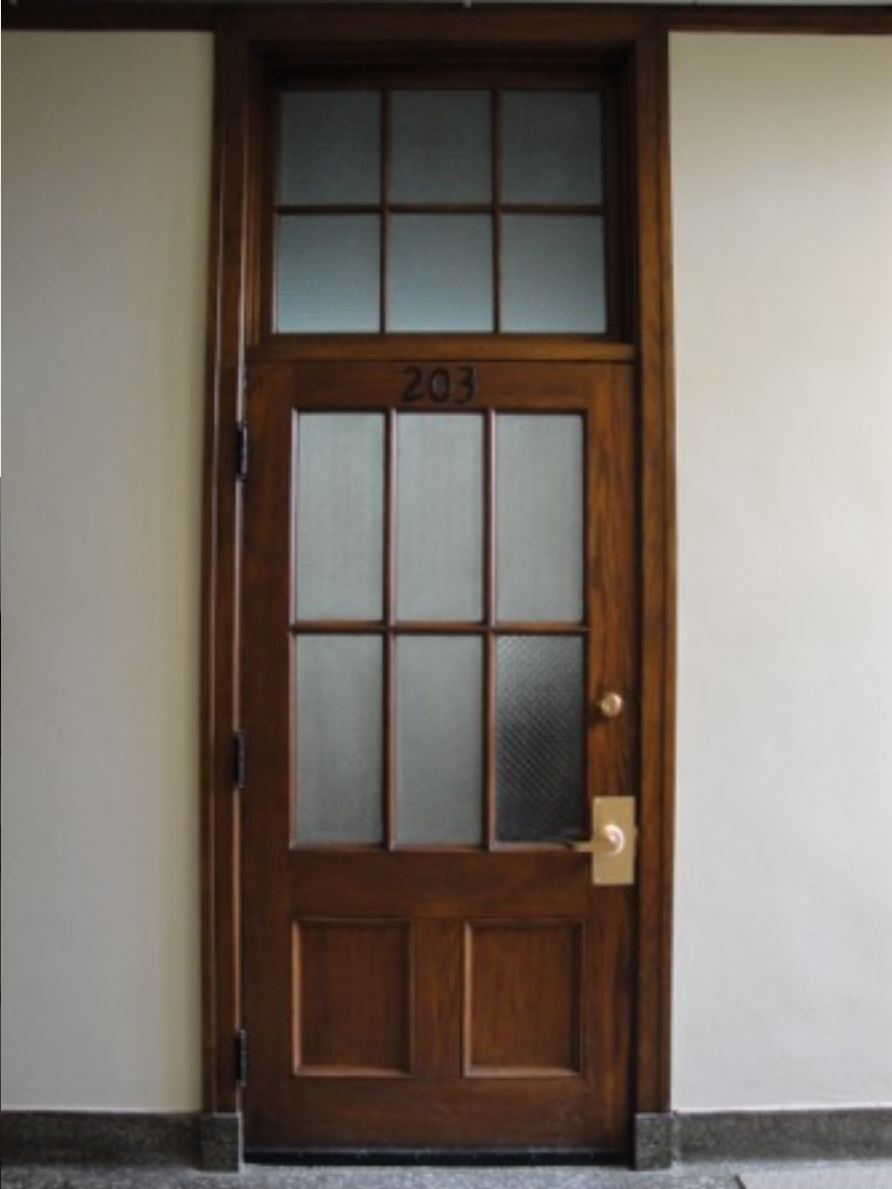
Applying the Standards: School Buildings

Vertical Circulation

Corridor Width

Original Hallway Features

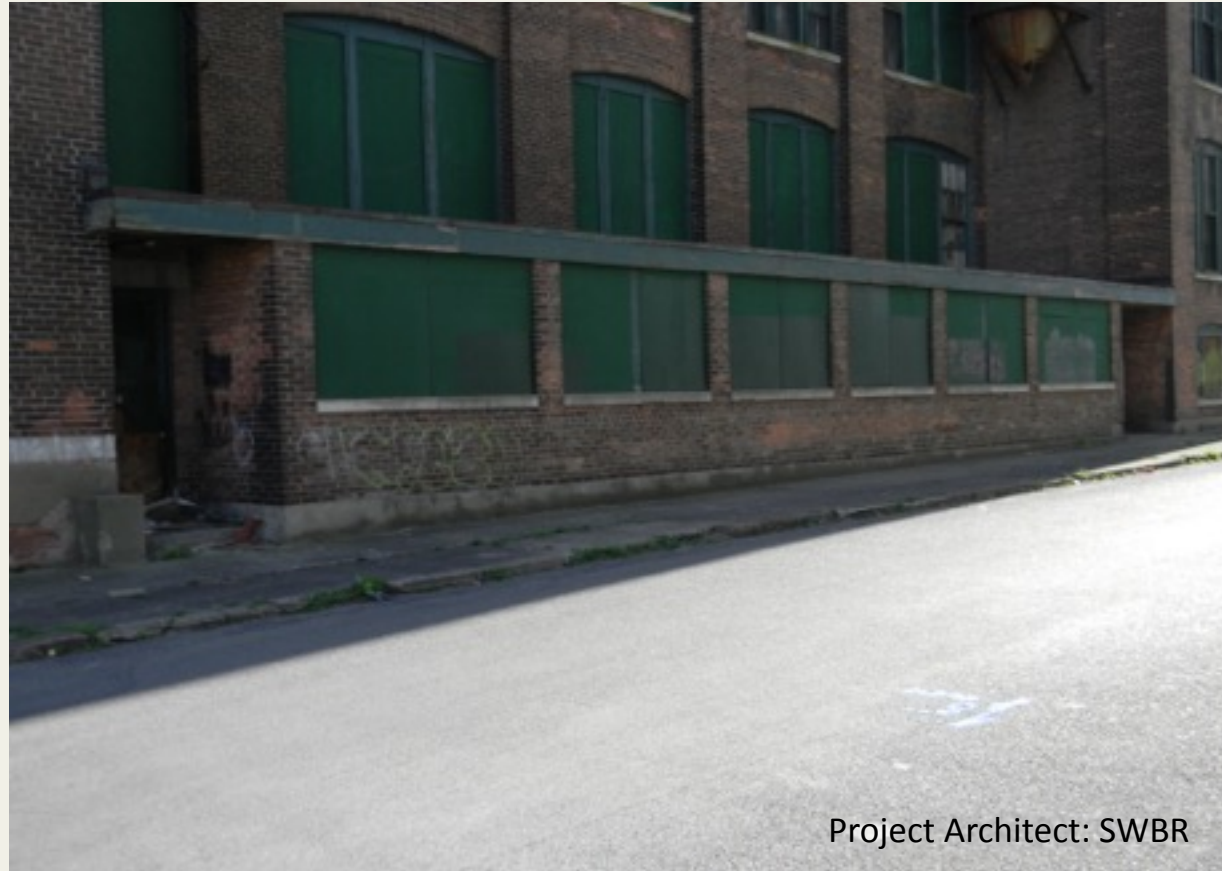
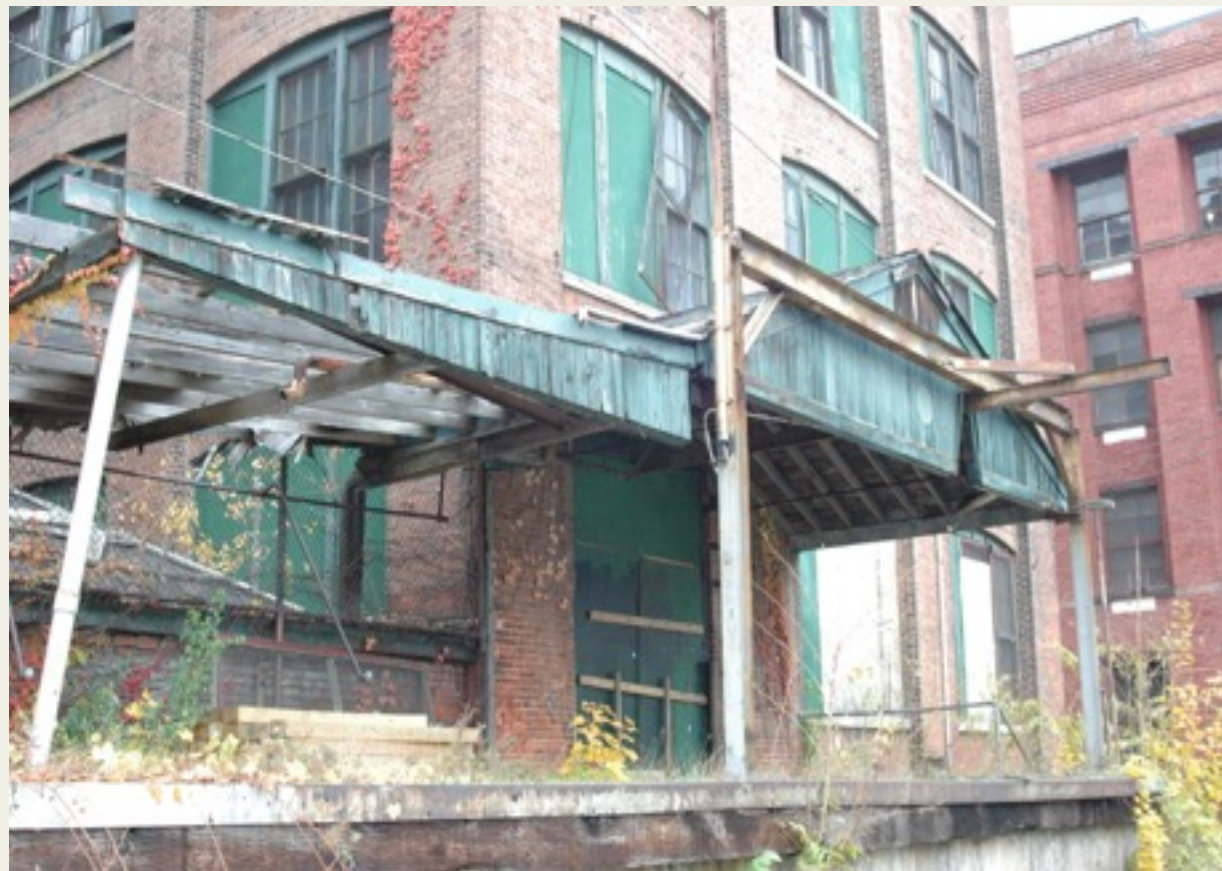
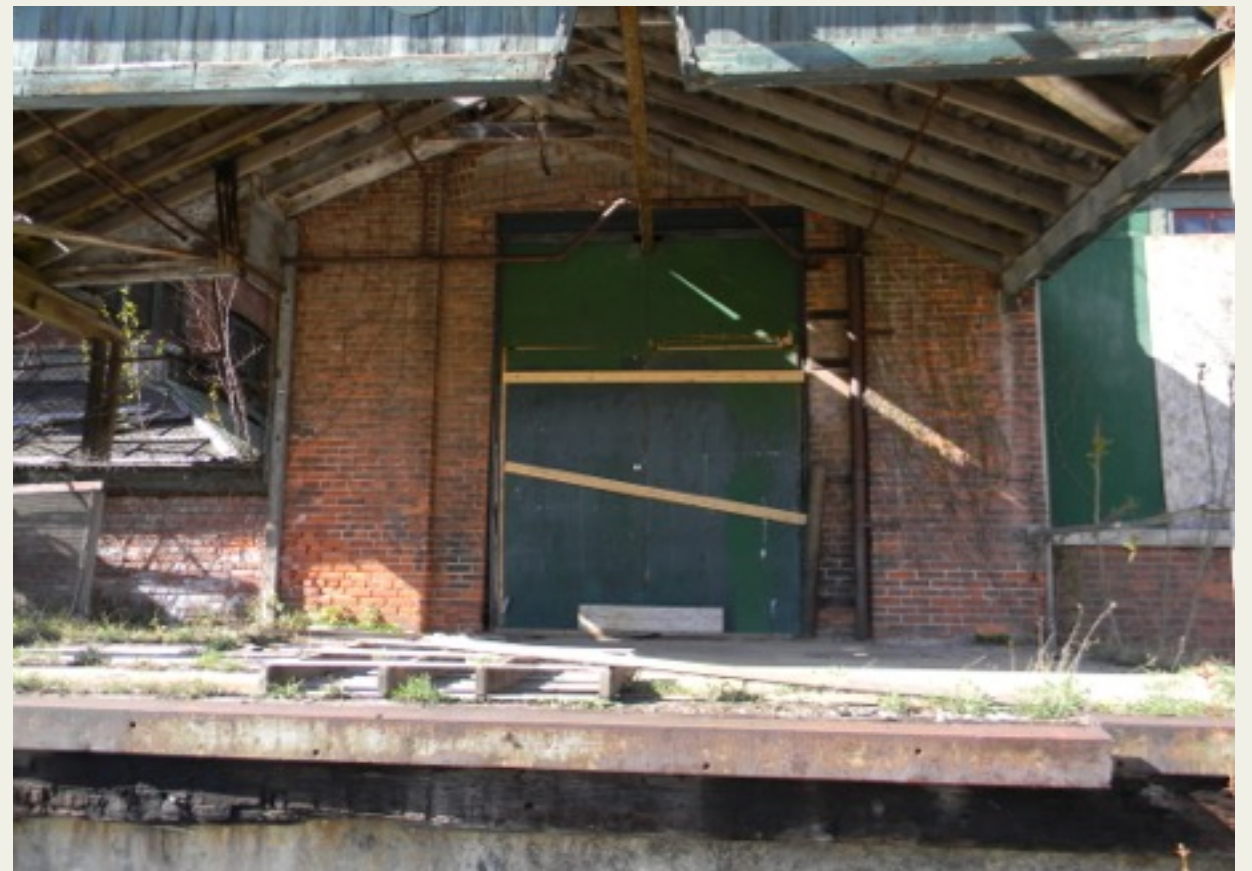
Applying the Standards: Important Changes Over Time

Standard No. 4

Most properties change over time; those changes that have acquired historic significance in their own right shall be retained and preserved.

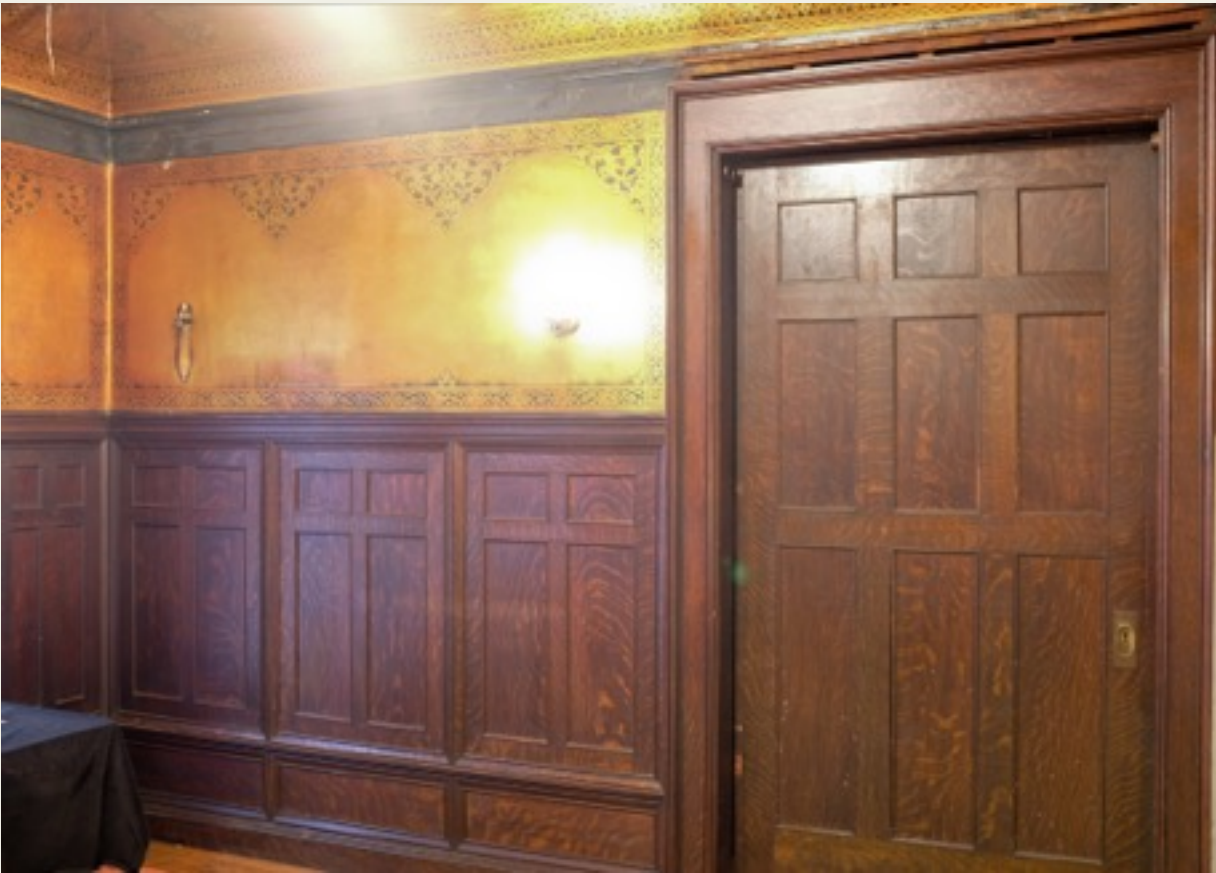
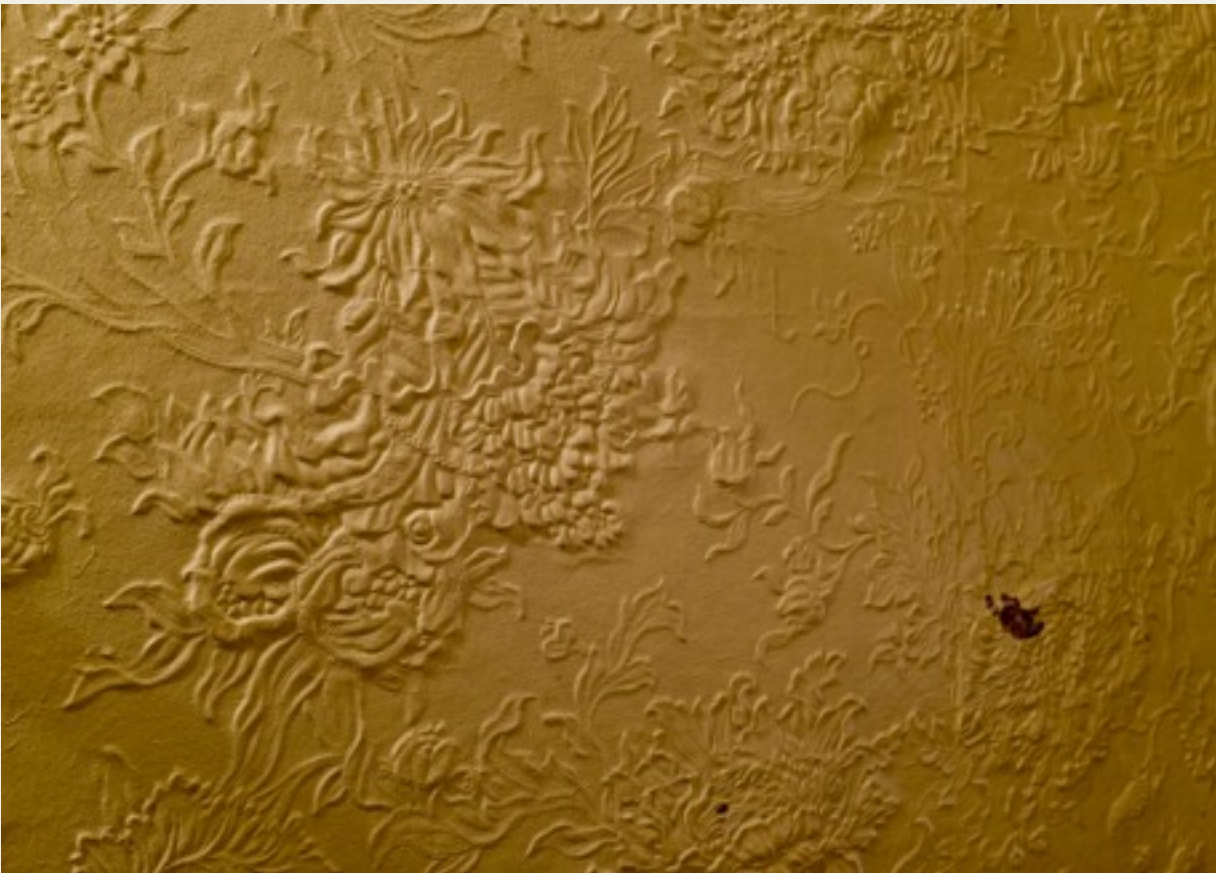
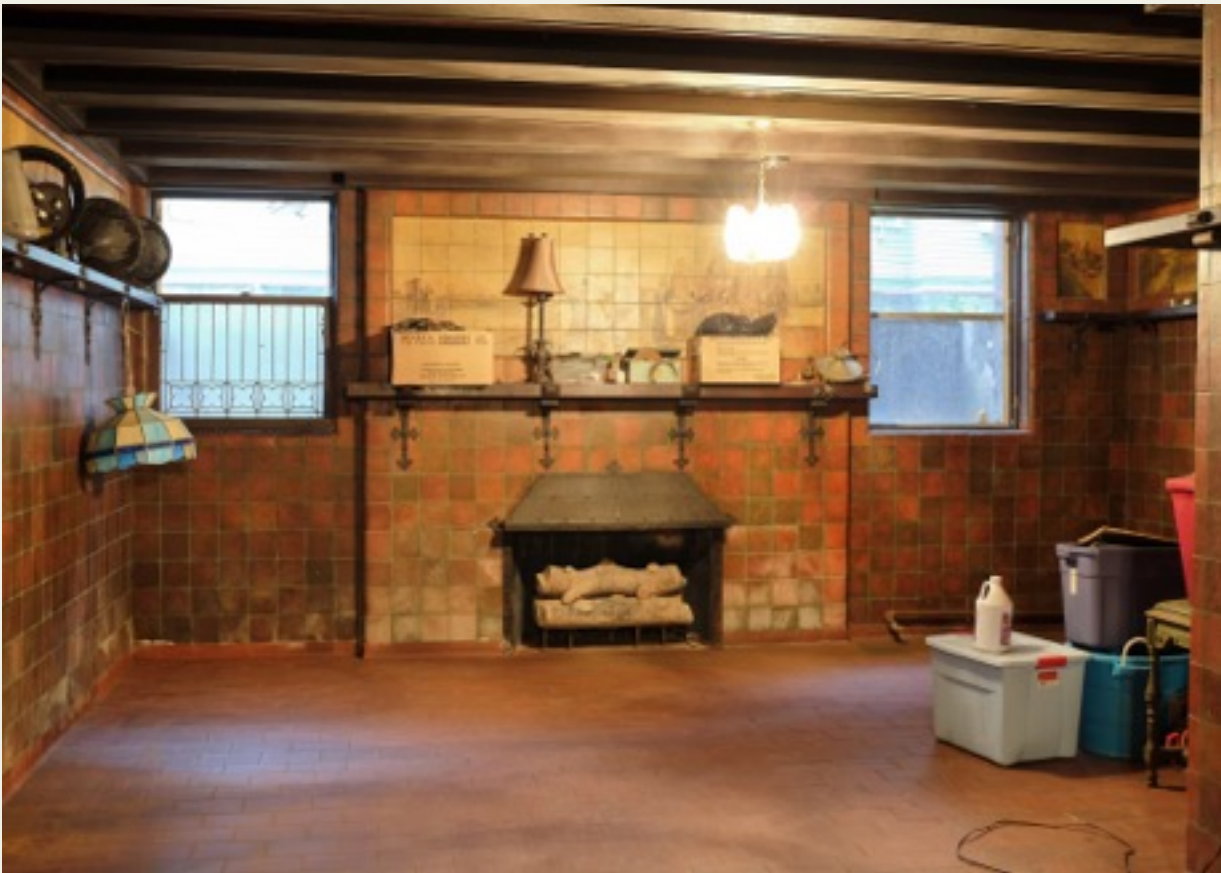
Applying the Standards: Highly Finished Space

Standard No. 5

Distinctive features, finishes, and construction techniques or examples of craftsmanship that characterize a historic property shall be preserved.

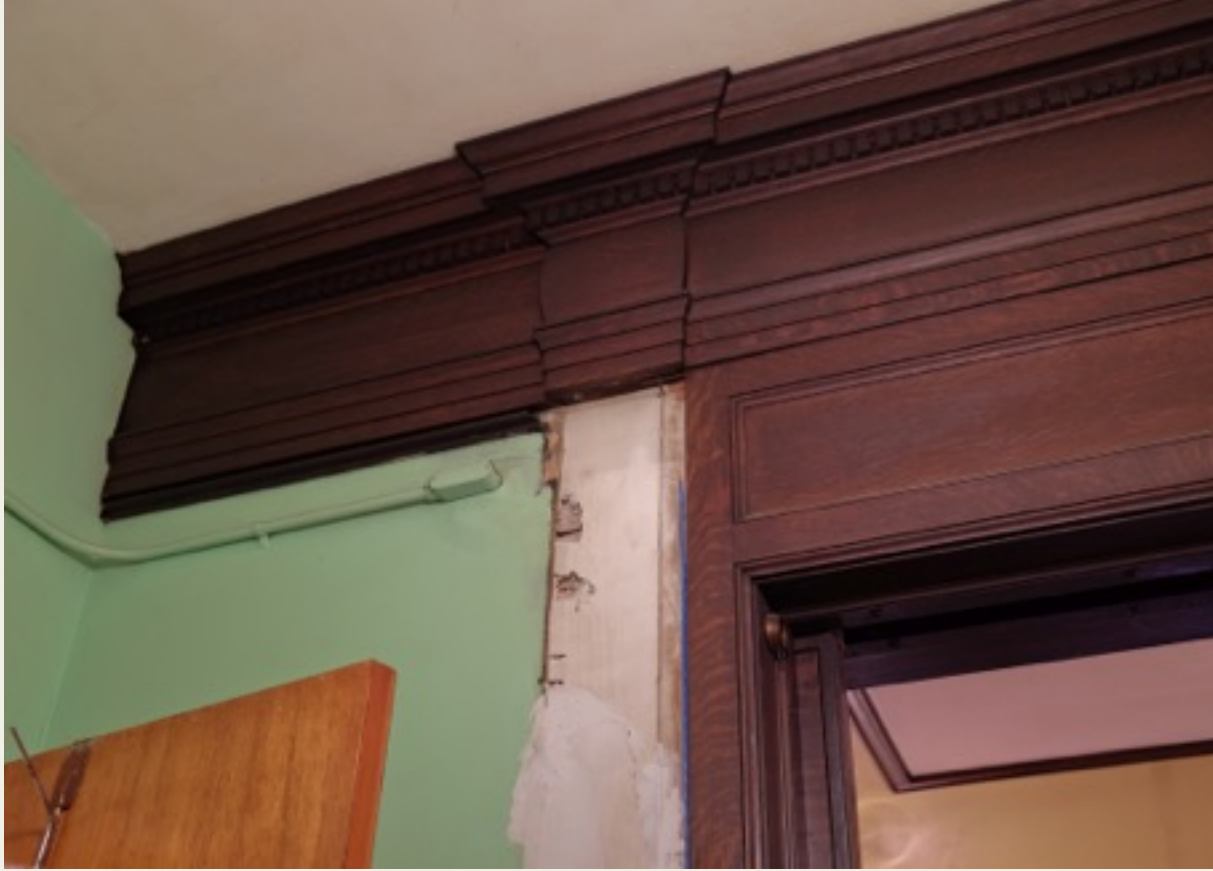
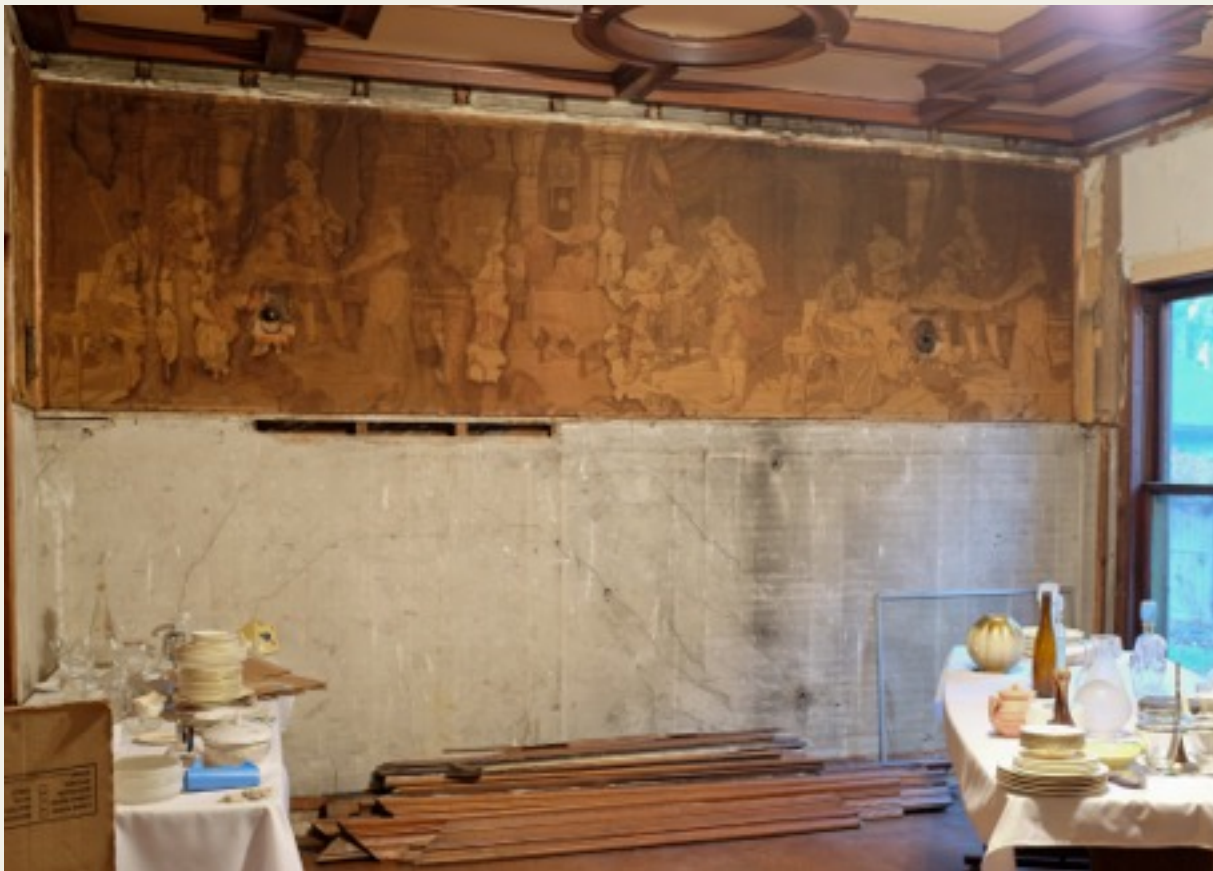
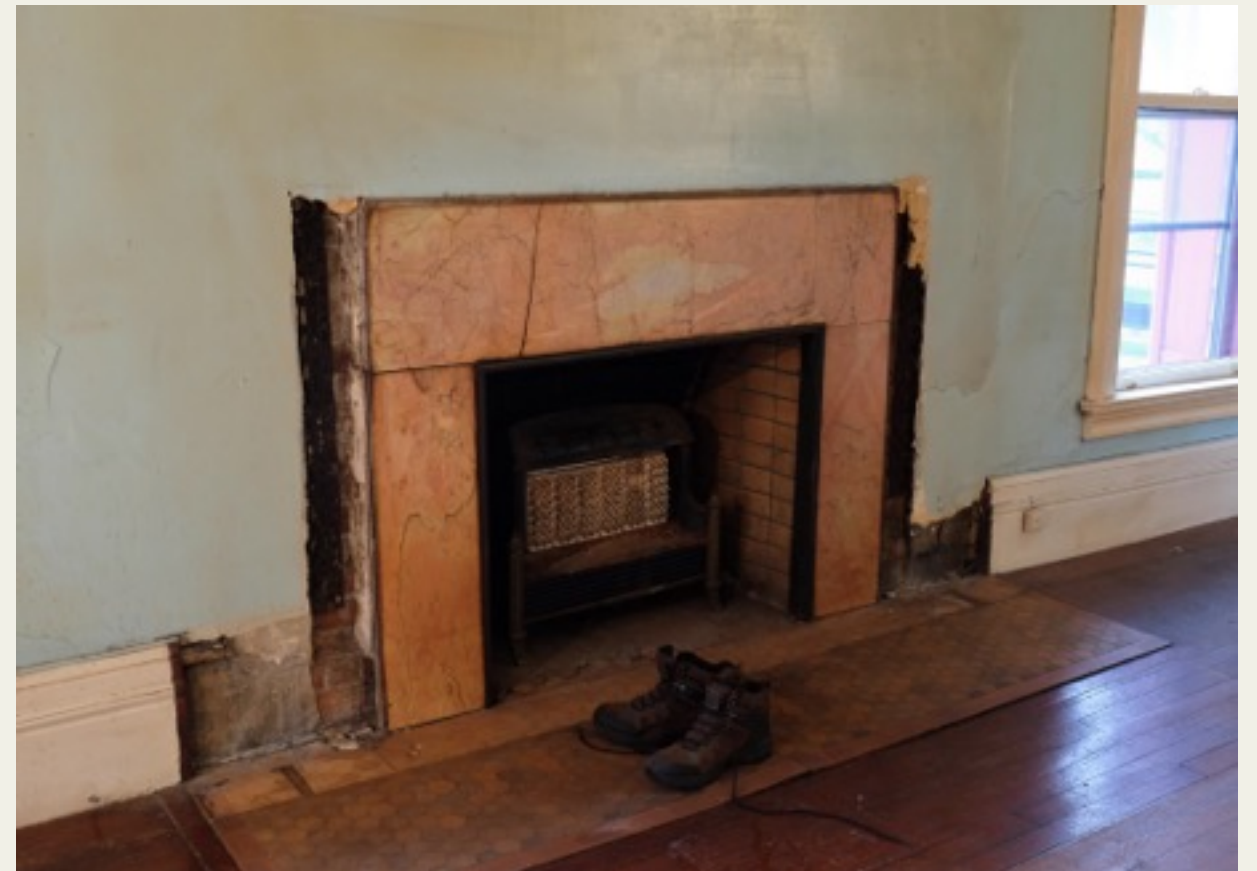
Applying the Standards: Repair or Replace In-Kind

Standard No. 6

Deteriorated historic features shall be repaired rather than replaced. Where the severity of deterioration requires replacement of a distinctive feature, the new feature shall match the old in design, color, texture, and other visual qualities and, where possible, materials. Replacement of missing features shall be substantiated by documentary, physical, or pictorial evidence.
