Rust Belt Real Estate:

Leveraging Rehabilitation Tax Credits

Preservation Studios LLC, Buffalo, NY

March 24, 2015

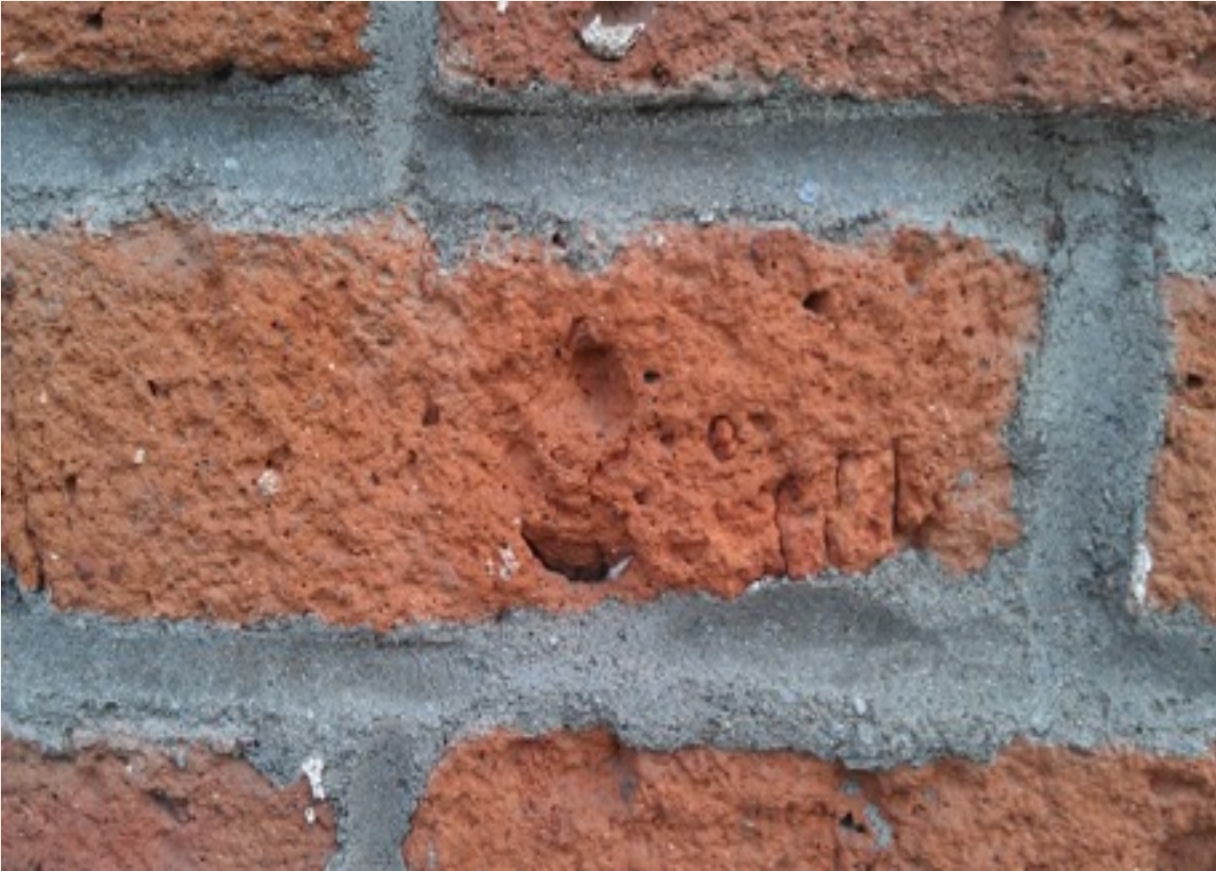
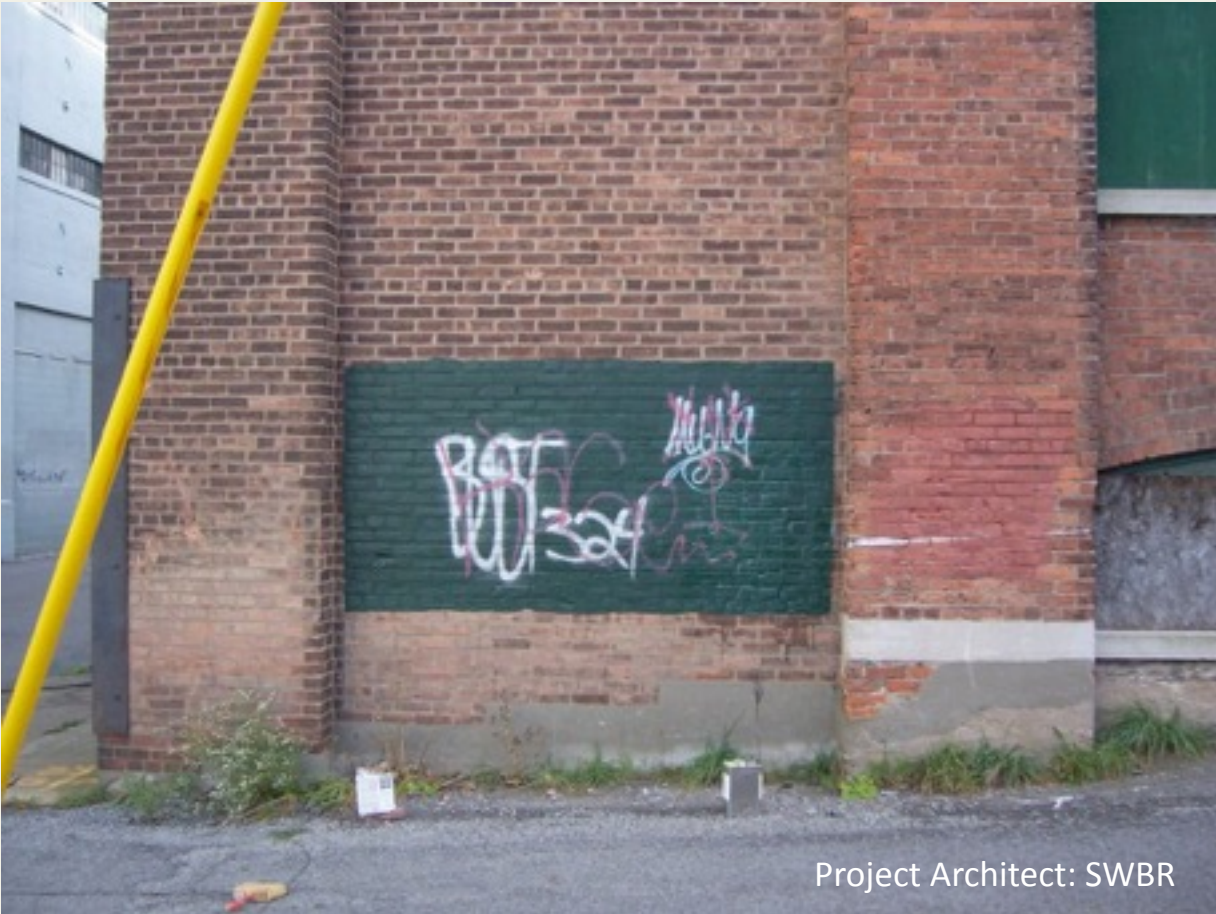
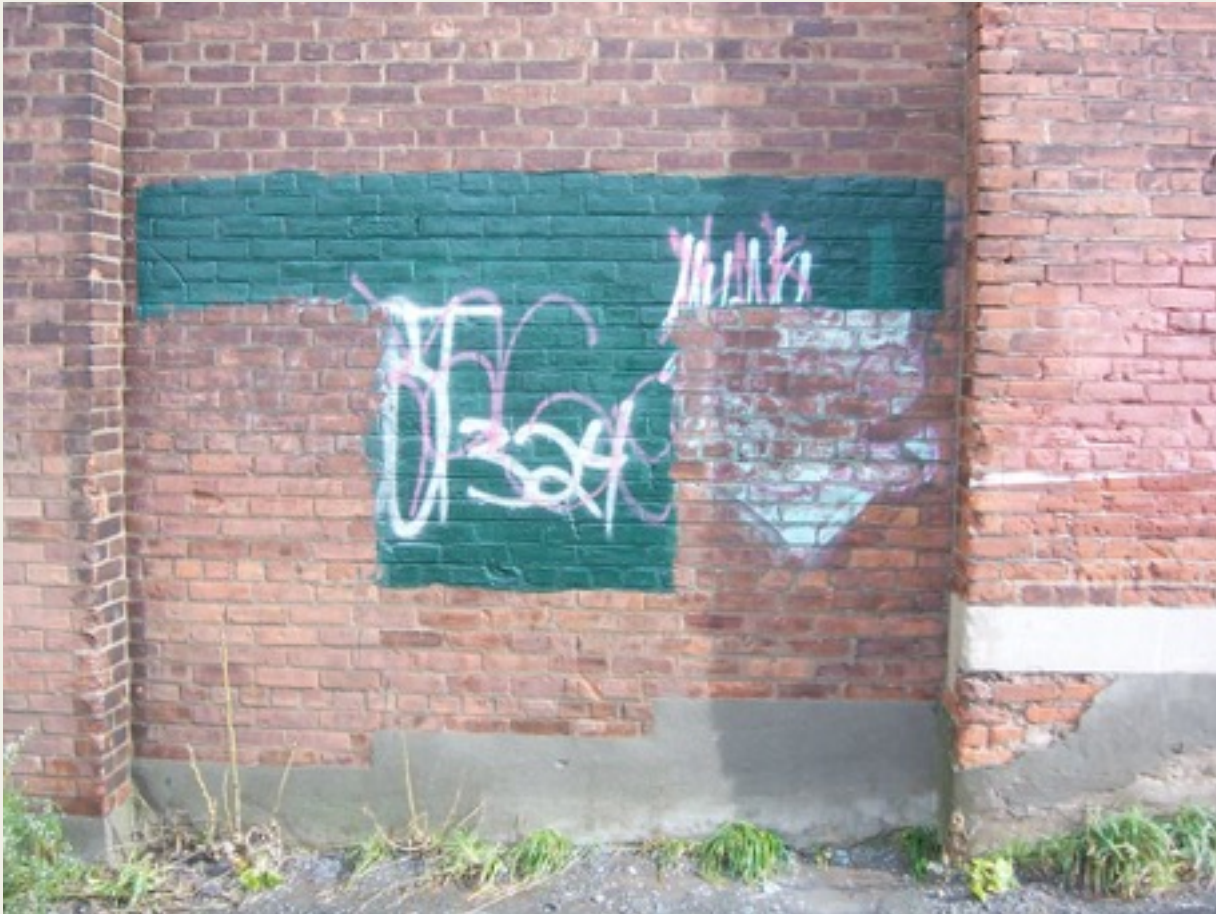
Applying the Standards: Gentlest Means Possible

Standard No. 7

Chemical or physical treatments, such as sandblasting, that cause damage to historic materials shall not be used. The surface cleaning of structures, if appropriate, shall be undertaken using the gentlest means possible.

Inappropriate cleaning and coating treatments are a major cause of damage to historic masonry buildings. While either or both treatments may be appropriate in some cases, they can be very destructive to historic masonry if they are not selected carefully. Historic masonry, as considered here, includes stone, brick, architectural terra cotta, cast stone, concrete and concrete block. It is frequently cleaned because cleaning is equated with improvement. Cleaning may sometimes be followed by the application of a water-repellent coating. However, unless these procedures are carried out under the guidance and supervision of an architectural conservator, they may result in irrevocable damage to the historic resource.

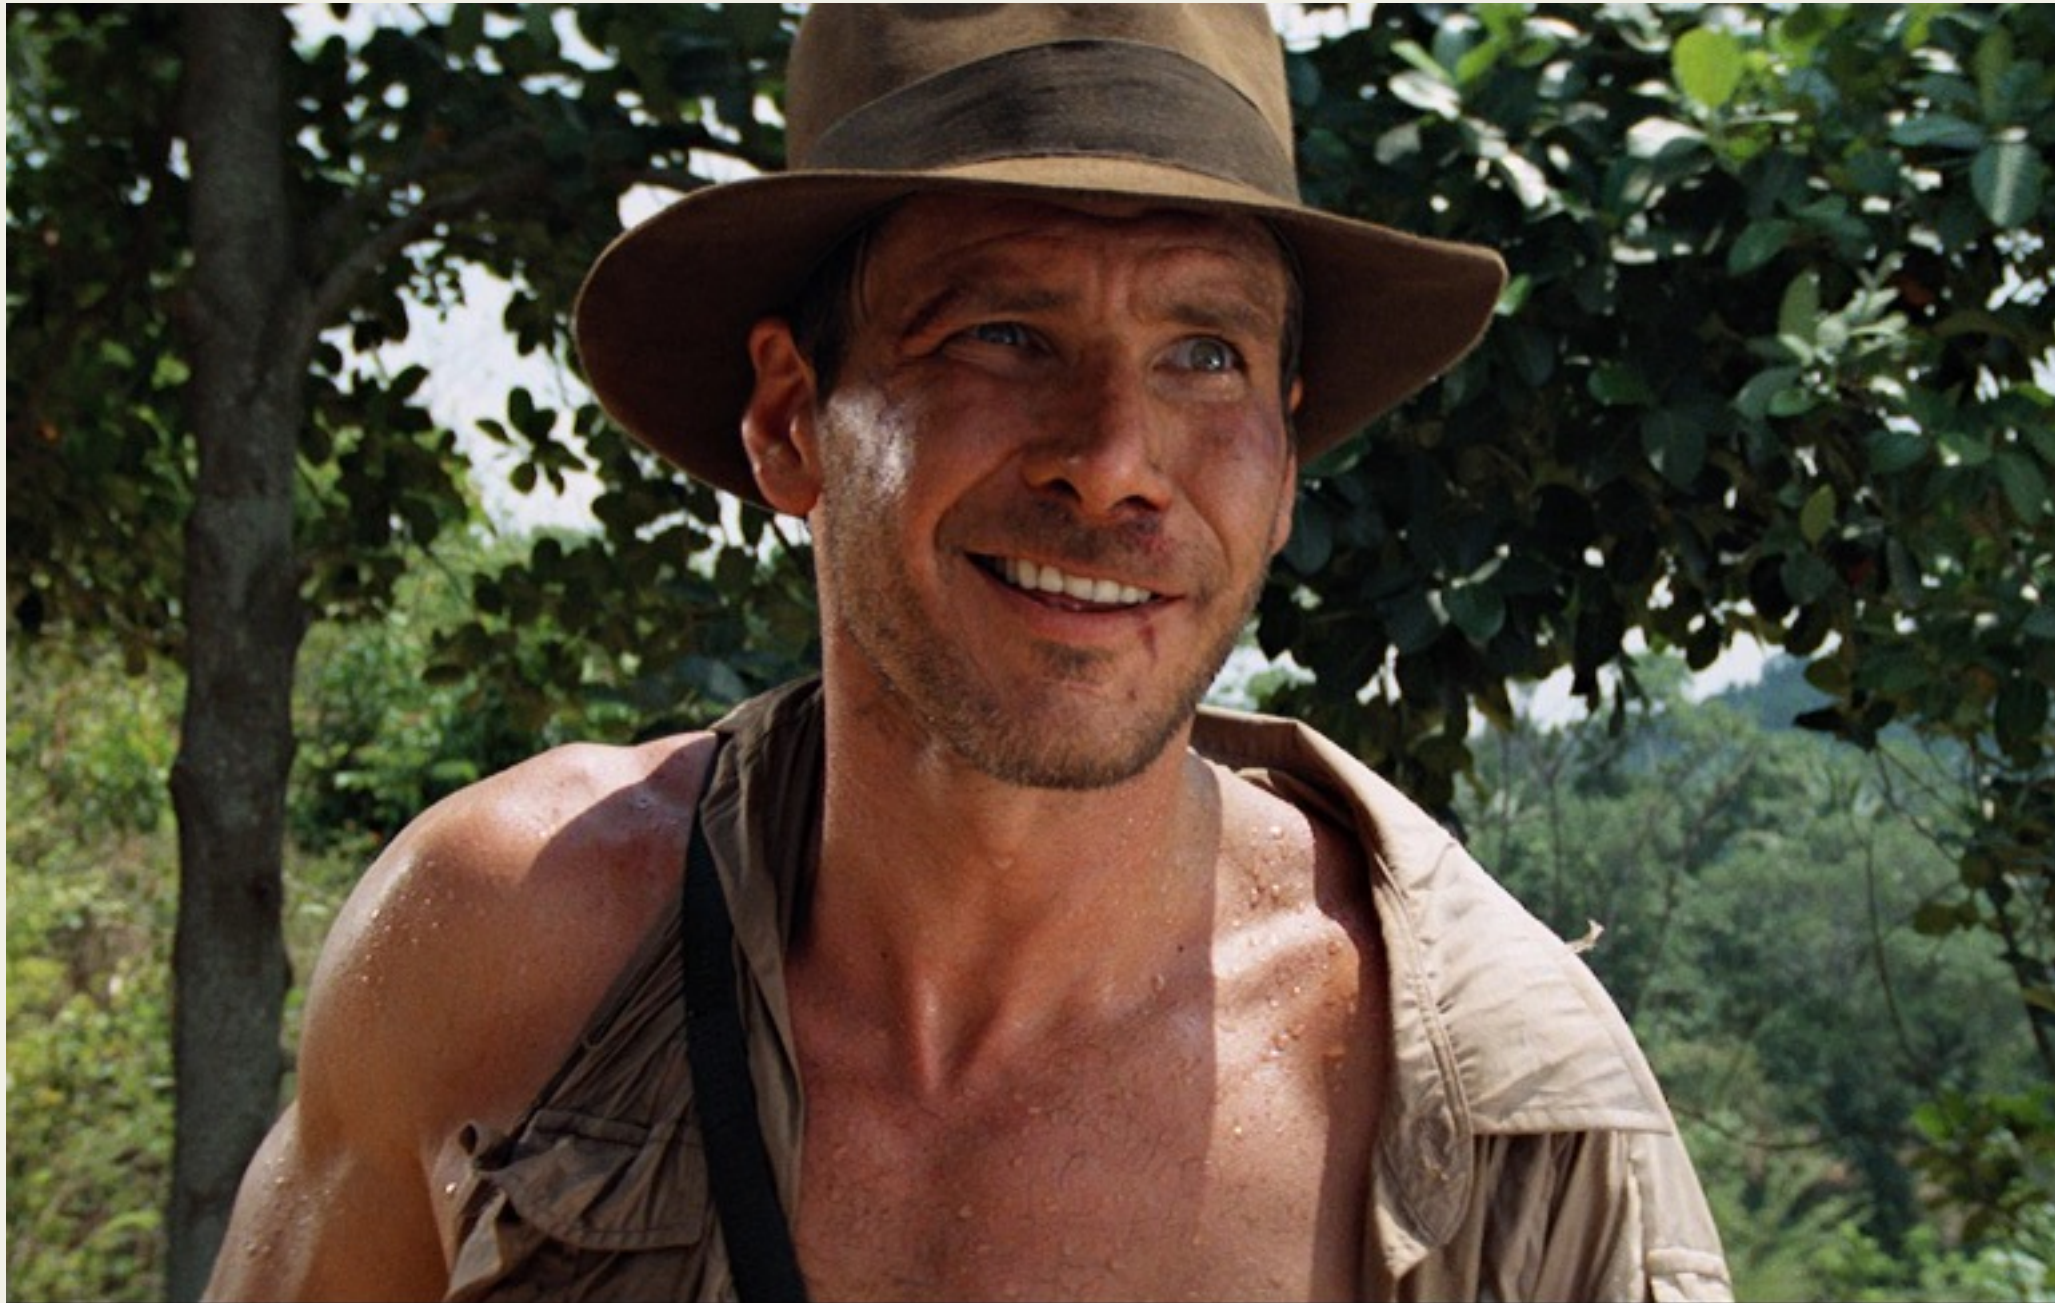
Applying the Standards: Archeological Resources

Standard No. 8

Significant archeological resources affected by a project shall be protected and preserved. If such resources must be disturbed, mitigation measures shall be undertaken.

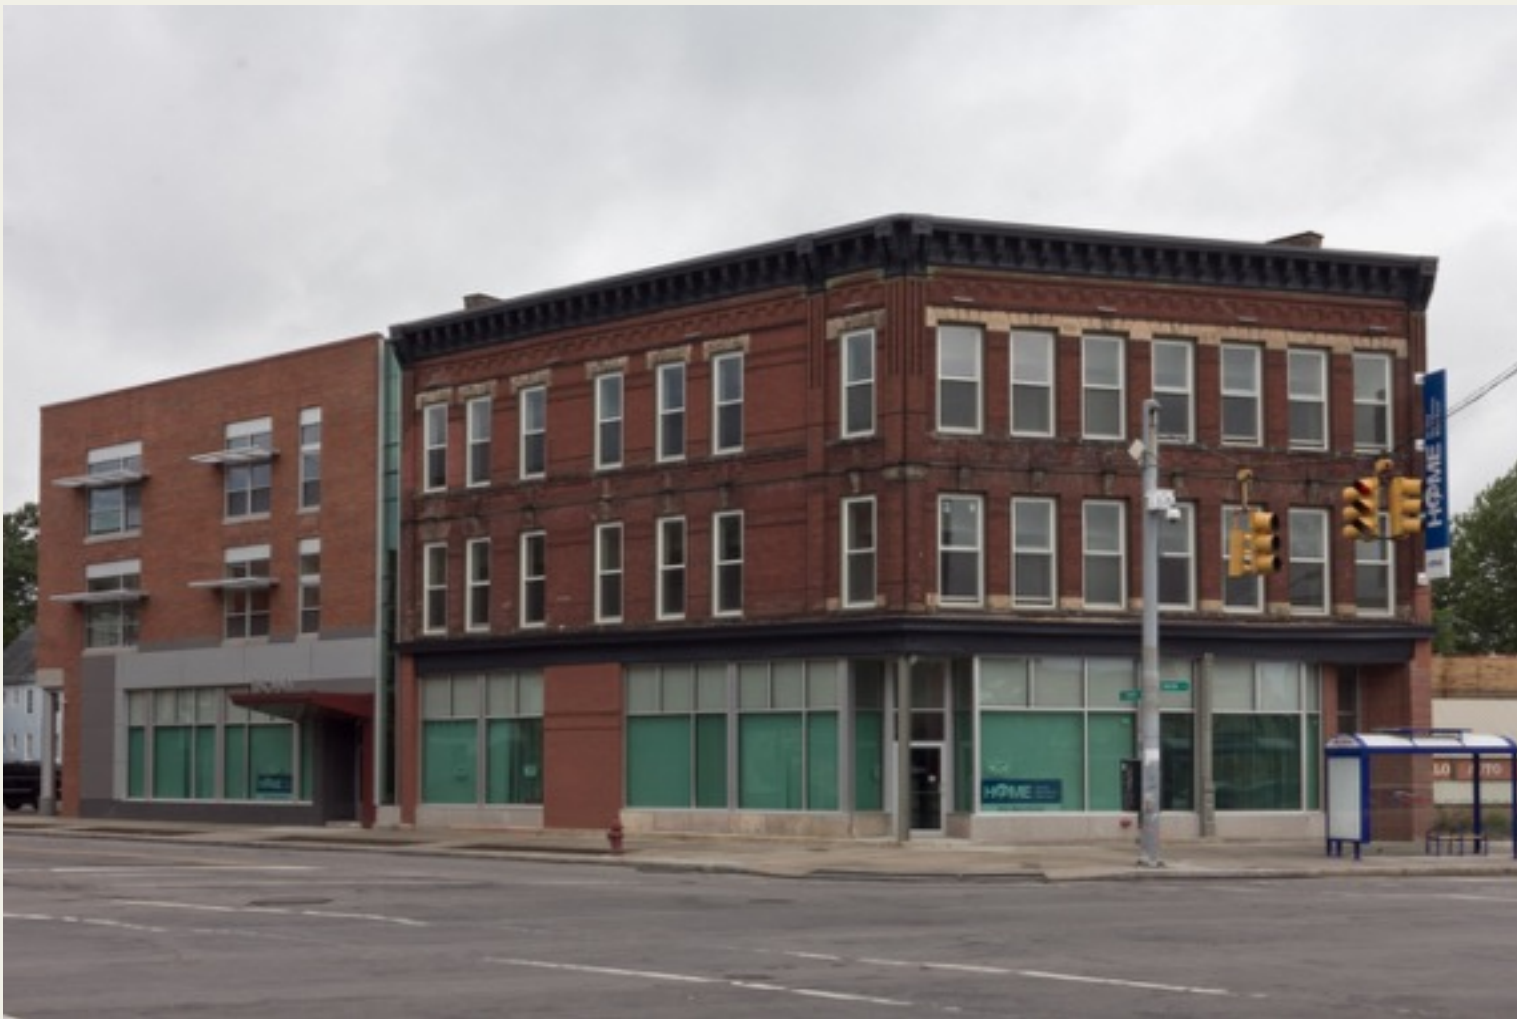
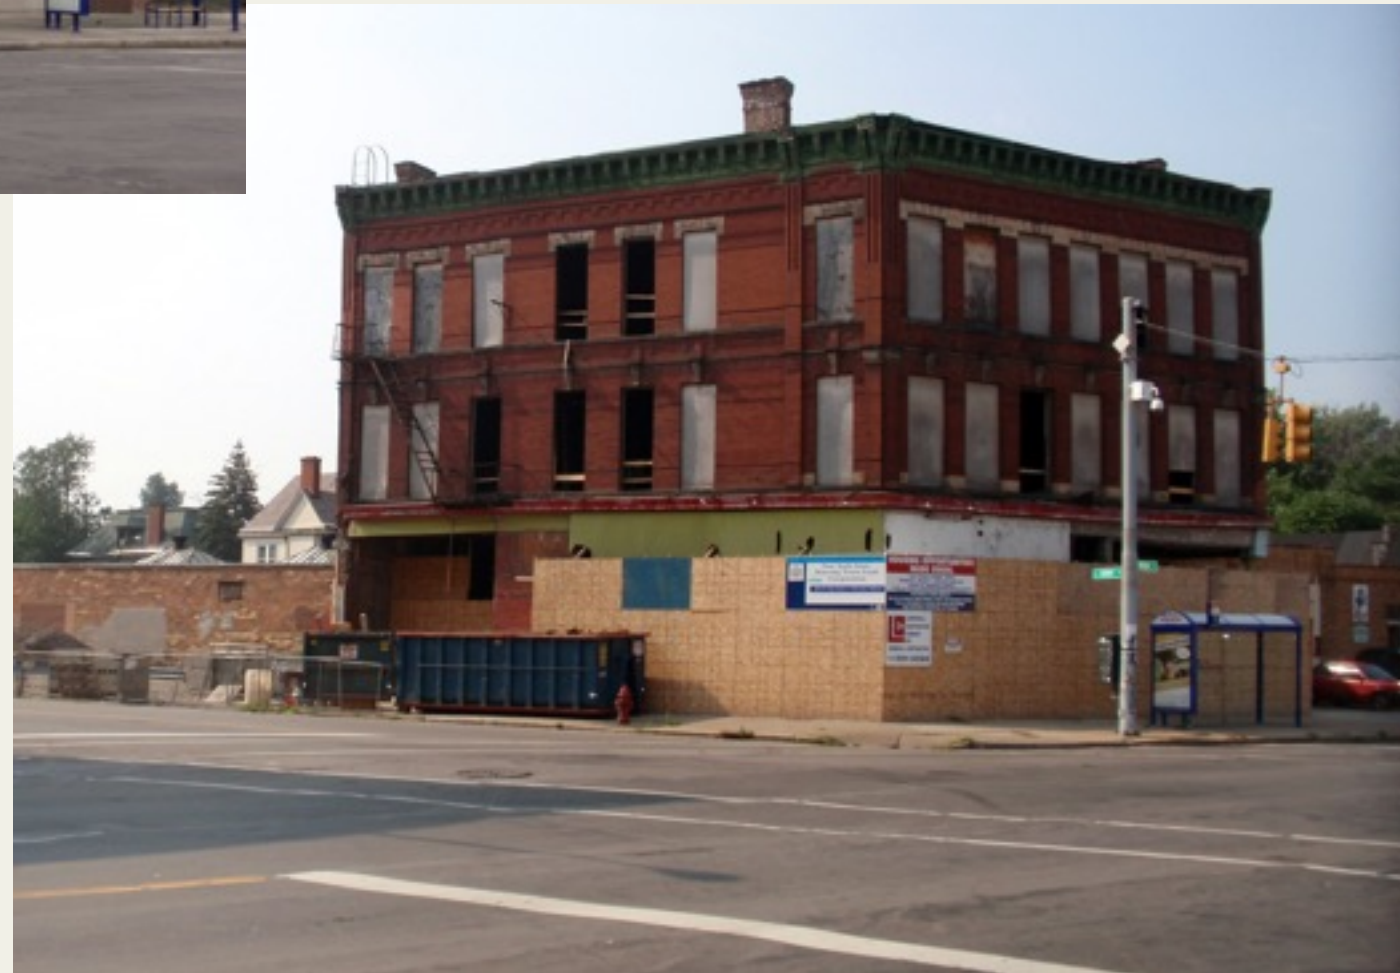
Applying the Standards: Appropriate Additions

Standard No. 9

New additions, exterior alterations, or related new construction shall not destroy historic materials that characterize the property. The new work shall be differentiated from the old and shall be compatible with the massing, size, scale, and architectural features to protect the historic integrity of the property and its environment.

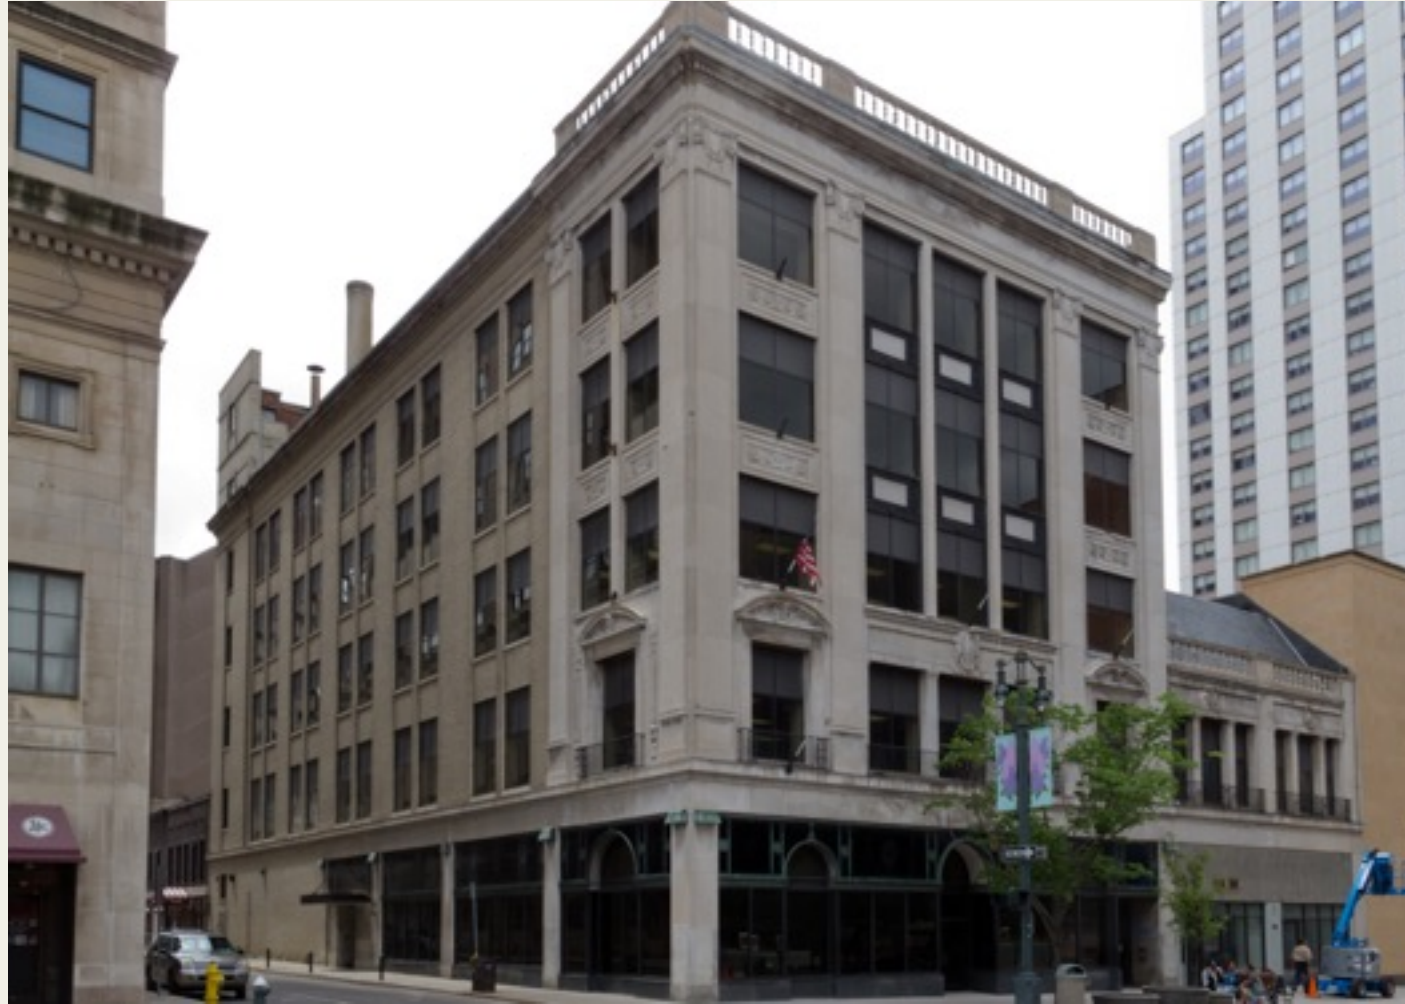
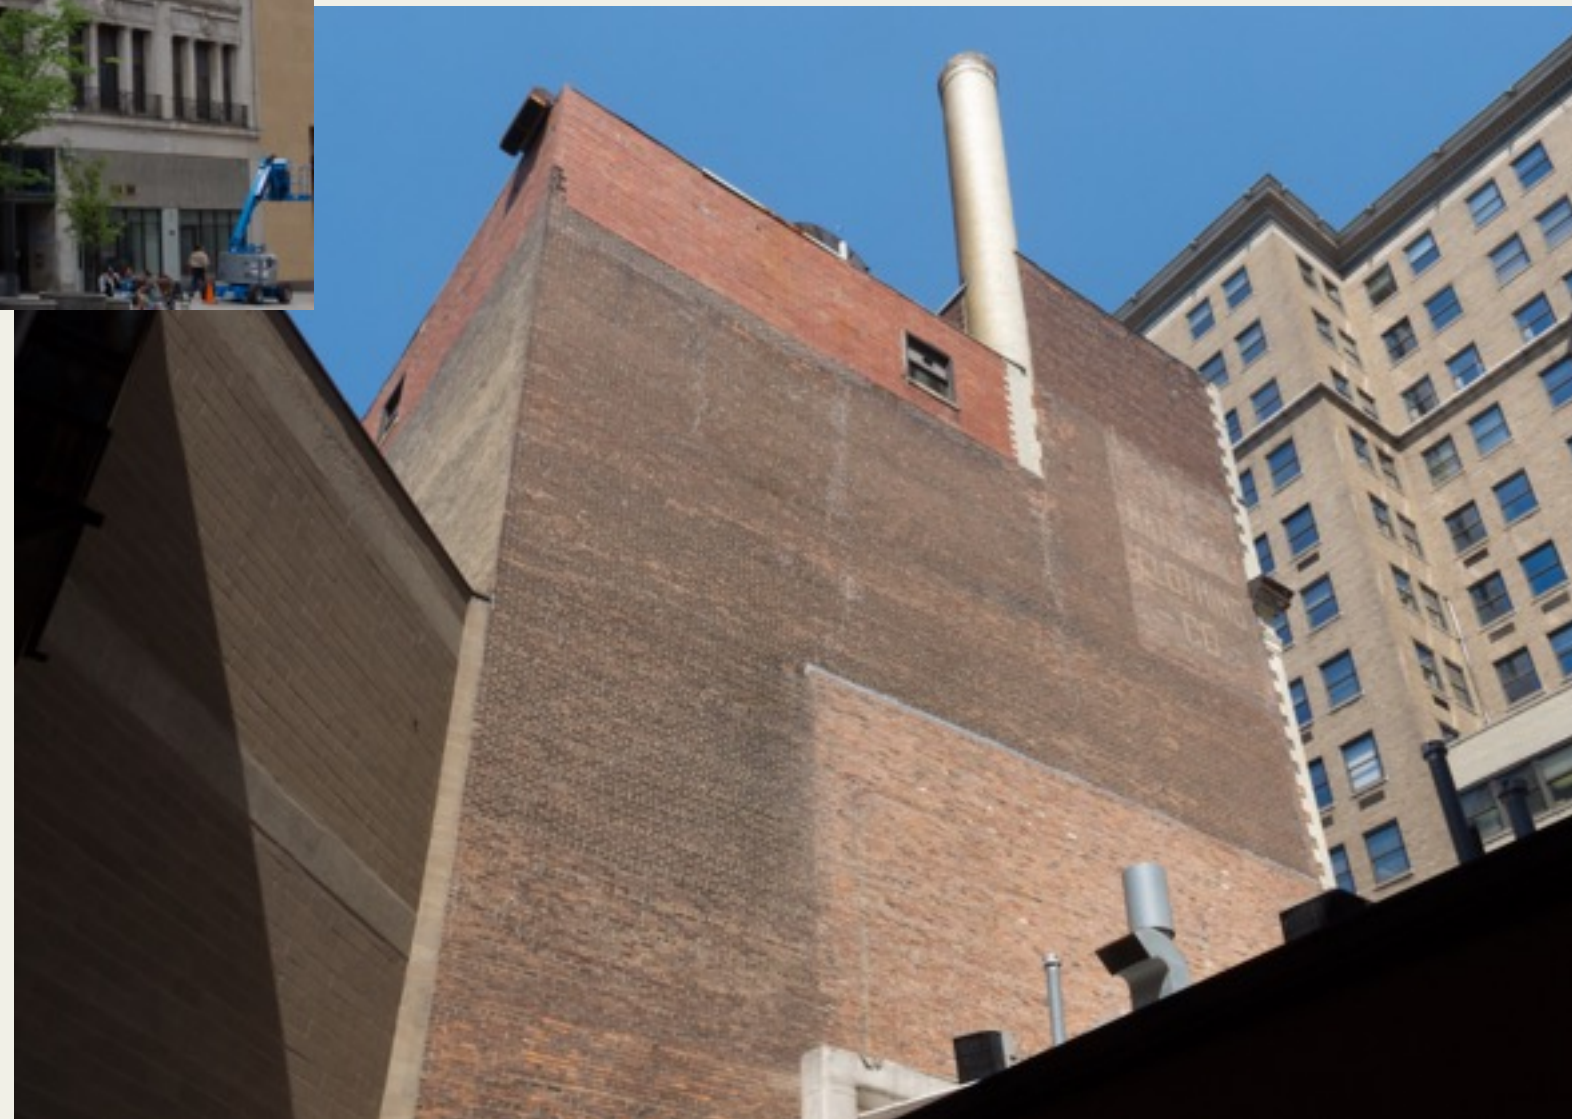
Applying the Standards: Appropriate Additions

Standard No. 10

New additions and adjacent or related new construction shall be undertaken in such a manner that if removed in the future, the essential form and integrity of the historic property and its environment would be unimpaired.
